WATERSHED RESTORATION PLAN For Big Creek, North Fork of the Flathead River

March 2003

Dean Sirucek , USDA Forest Service, Flathead National Forest

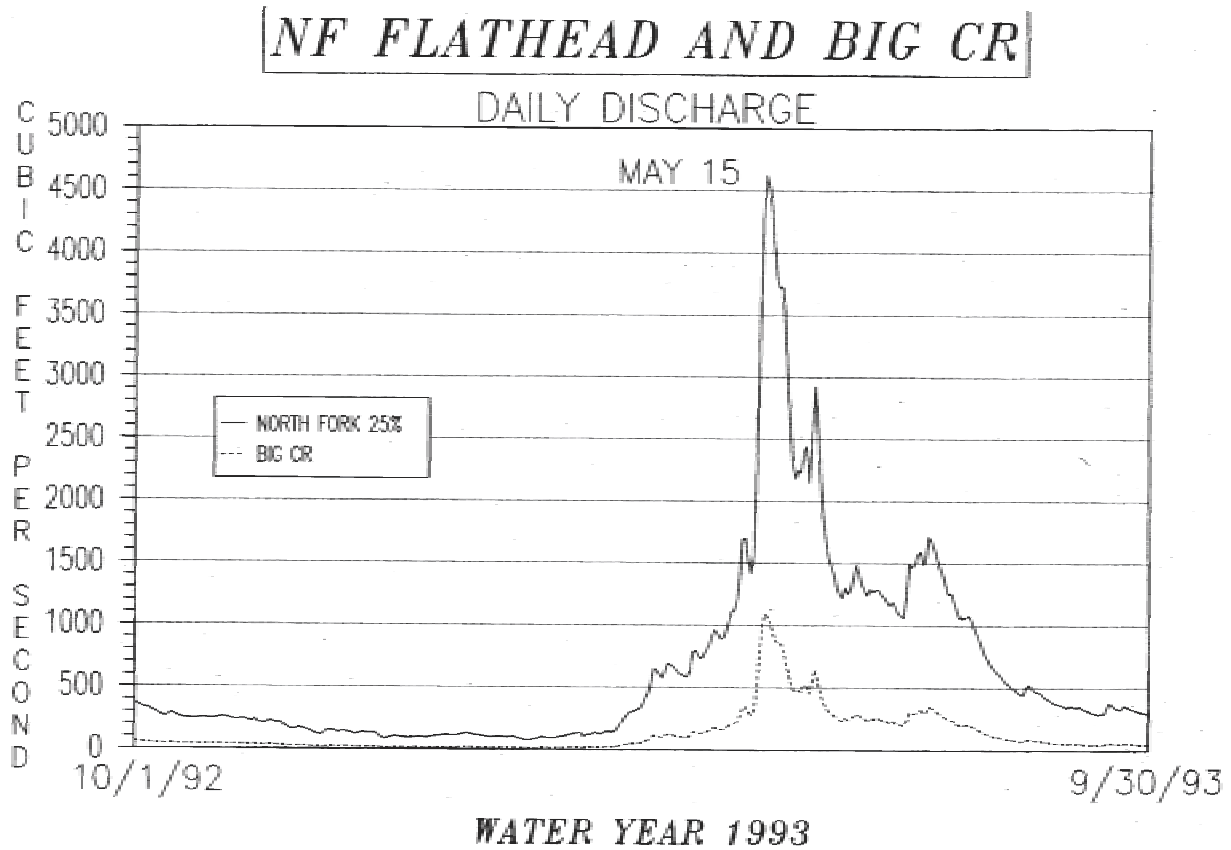
Figure – 3: is a comparison of the water flow in cubic feet/second for the 1992 water-year at the water quality monitoring site in lower Big Creek and on the mainstem of North Fork of the Flathead River, at Glacier Rim.

As previously described, peak streamflow usually occurs in late May or early June from spring snowmelt. Flood flows rarely overtop the channel banks of Big Creek and erode adjacent land areas. High flows that erode the upper banks of the channel occur every three to five years. The last high flow was in the spring of 1998 from the snowmelt of an unusually deep snow pack. There was a stream flow gauge located at Lookout Bridge at Big Creek. Stream flow measurements were taken there from early spring till late fall for several years. During that time 2,424 cubic feet per second (cfs) flow levels were recorded. The maximum recorded flow was 2,404 cfs and the minimum flow was 9 cfs, with the mean flow being 187 cfs. Figure – 3 shows a comparison of the water flow in cfs for the 1992 water-year at the water quality monitoring site in lower Big Creek and on the mainstem of North Fork of the Flathead River, at Glacier Rim

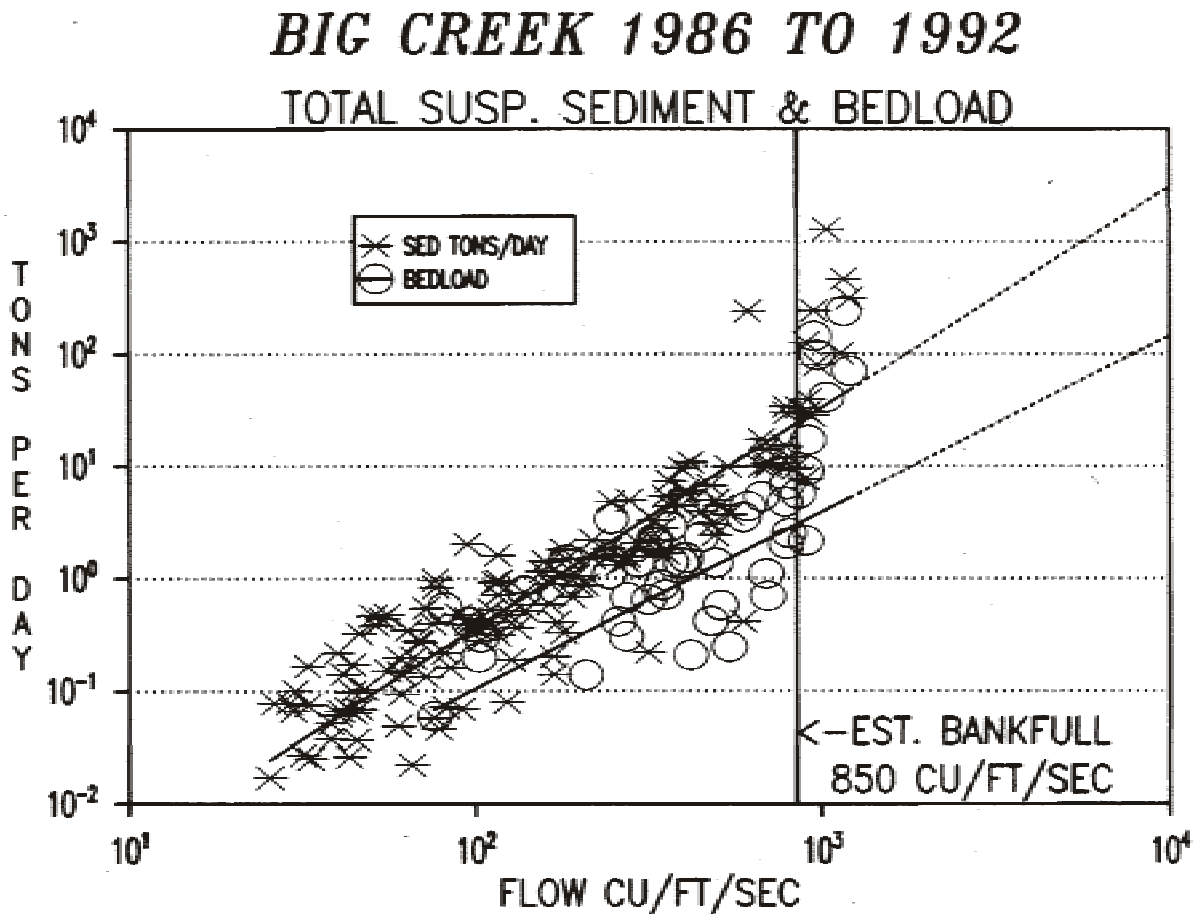
Figure – 4 The total suspended sediment and bedload versus stream discharge for Big Creek, for the years 1986 to 1992.

At this monitoring site, annual sediment yield is variable, as streamflow increases, suspended and bedload sediment loads increase. Sediment pulses occasionally move downstream after a mass failure or other major sediment producing action occurs upstream. However, it is during the annual snowmelt peak discharge that sediment transport rates are predictably high and the duration of high sediment transport rates seems to be a function of the duration of bankfull and higher streamflow. Graphs of relationship of total suspended sediment and bedload to stream discharge are displayed in Figures - 4.

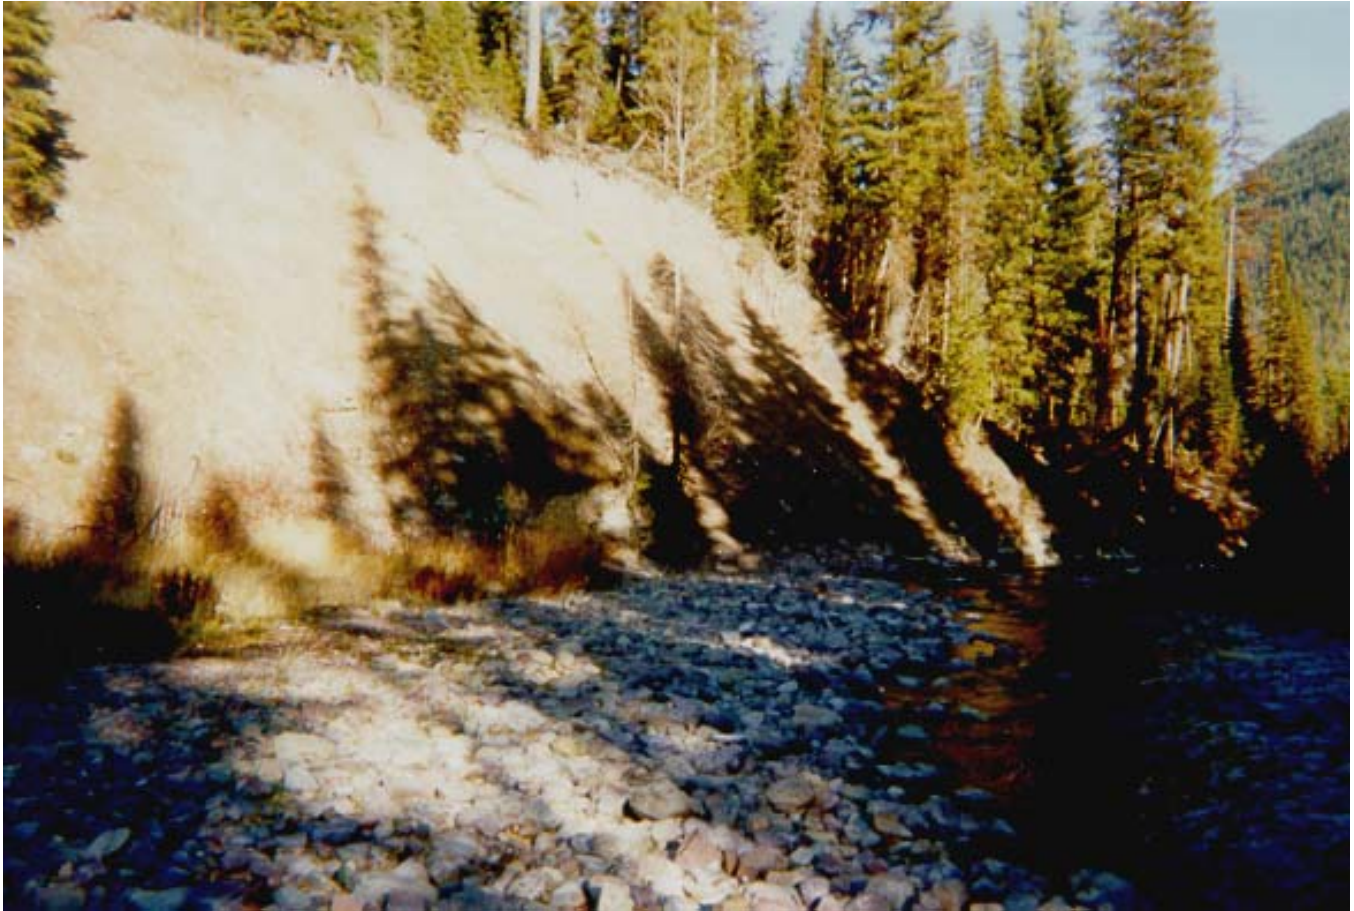
Photograph - 7: Example of an eroding stream terrace escarpment.

Situation - 1 Streambank Erosion: The mid to lower reaches of the mainstem of Big Creek flows through glacial-fluvial deposits, in which the stream has downcut in excess of 100 feet since the retreat of the glaciers (10 -12,000 years before present). This downcutting of the stream has resulted in an abandoned Pleistocene age stream terrace, with a very steep (60-80% slope) terrace escarpment leading down to the current stream terrace and floodplain. Some place along this escarpment the stream comes into contact with it during normal spring runoff or other peak flow events. During high flow periods, the toeslopes of these exposed soil banks are eroded by the flowing stream putting significant amounts of sediment into the stream. Streambank erosion in excess of one foot has been observed by the author during a high flow event on these types of escarpments. The erosion of these terrace escarpments is a natural process. However, the additional water flow during peak flow events caused by logging and road construction, causes the stream to be in contact with these sediment sources more often and for a longer duration than during pre-management times. At the same time, the steep escarpment banks have large areas of unvegetated eroding soil. Refer to photograph – 7 for an example of an eroding stream terrace.

There are seven areas along the mainstream of Big Creek, where the stream is impinging upon these escarpments causing a major sediment source. These sites will be examined carefully to see if instream structures such as vortex-weirs, rock barbs, or tree stump armoring would help the situation and can be logistically installed with the limited access to the stream. This examination needs to be done in concert with the Montana Department of Fish, Wildlife and Parks, along with the U.S. Fish and Wildlife Service. Once the eroding bank is armored then there will be an attempt to establish vegetation (shrubs) on the toes of the eroding slump banks, to trap the eroded soils from the steep

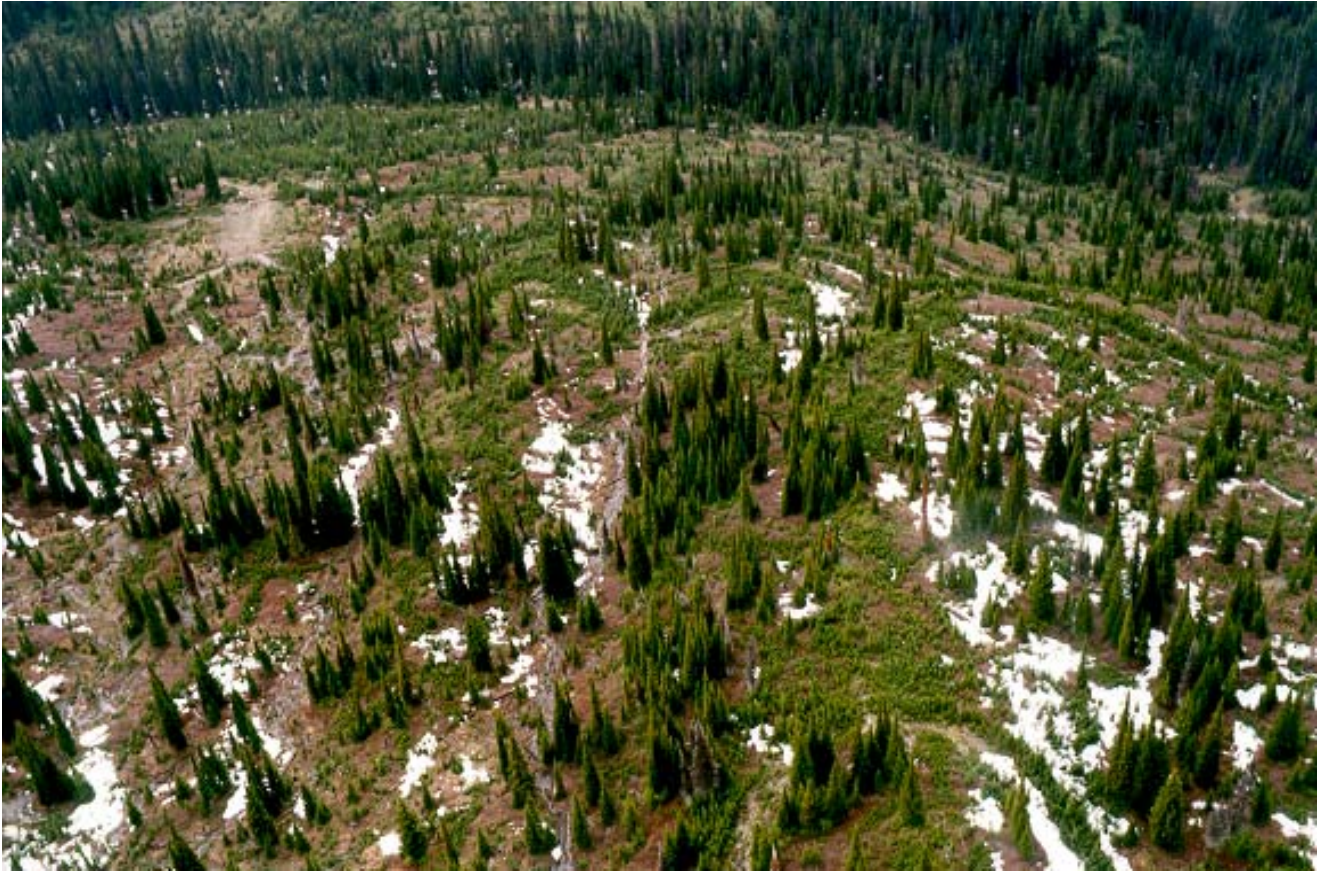
Photograph – 8: An example of a skid-stream.

Situation - 2 Skid Trail Rehabilitation: Skid trails to remove logs from cutting units were developed by cats and skidders during past timber harvest activities. Most of the skid trails developed in the past 20 years were waterbarred when the skidding was completed. The waterbarring disperses the water before it is concentrated into a defined flow that causes erosion. Some of the earlier skid trails and/or the log landings where the skid trails converge have had very small streams (*skid-streams*) develop on them due to soil compaction and intercepted groundwater. These small skid-streams typically only run water during snowmelt or high intensity rainstorms, however, this does increase the peak flow response within the basin. The majority of these skid-streams have eroded away the fine textured soils within their stream bottoms and bank, causing them to be well armored by cobbles and stones, and typically well vegetated. Going back and constructing waterbars at this time would disturb the established vegetation and expose soil to be potentially eroded. Refer to photograph – 8 for an example of a skid-stream.

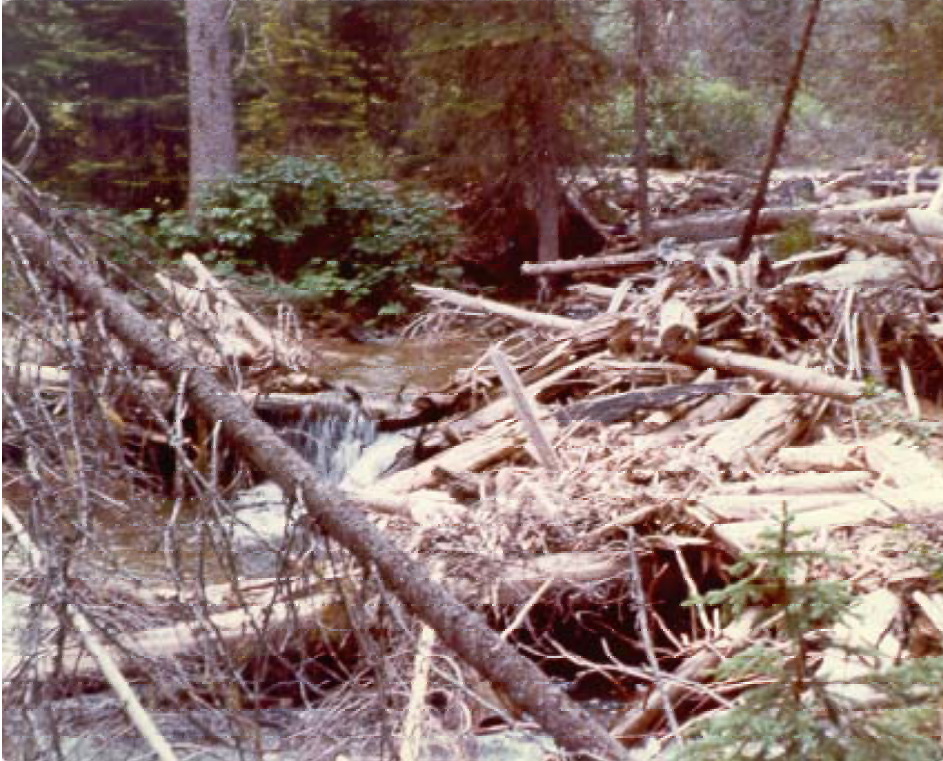
Photograph – 9: Example of concentrated piles of large woody debris in the Big Creek stream channel.

Situation - 5 Log Jam Stabilization: There are several sites (5-6) along Big Creek where logjams (concentrated piles of large woody debris) in the stream are causing the stream to erode a new channel. Refer to photograph – 9. The removal of portions of the logjams, in some cases, would in the short-term reduce the amount of channel erosion. However, there are sediments trapped behind these logjams. Therefore, the removal of the any woody materials from these logjams would be done in a manner to minimize any movement of the trapped sediments. The removal of these logjams would cause minimal stream channel disturbance by the use of manual labor and chainsaws if possible, rather than heavy equipment.
