**SALMON AND STEELHEAD  
HABITAT LIMITING FACTORS ASSESSMENT  
WATERSHED RESOURCE INVENTORY 49:  
OKANOGAN WATERSHED**

**CONFEDERATED TRIBES OF THE COLVILLE RESERVATION**  
Okanogan, WA

**ENTRIX, INC.**  
Seattle, WA

**May 14, 2004**

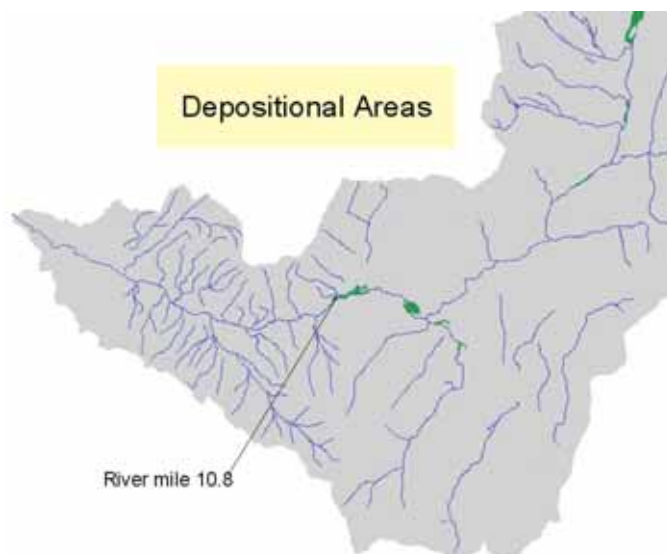
**Figure 5-1.** These areas effectively improve water quality by slowing the stream.

Functioning depositional areas exist on Bonaparte Creek to allow these fine sediments to fall out and deposit on the streams banks and channel bottom. The "new" soil is then held in place by opportunistic plants. Identified functional depositional areas are approximately at river mile 10.8, 12.9, both near the confluence of Peony and Bonaparte Creek. In Upper Bonaparte Sub-watershed functioning depositional areas exist on Bonaparte Creek approximately at river mile 20.0, downstream from intersection of Bonaparte Lake road and Hwy. #20, river mile 23.0, confluence with Lightning Creek, river mile 24.5, non-channeled portion of Bonaparte Meadows. Peony Creek has two depositional areas. Both are located near Aeneas Valley road crossing (**Figure 5-1**).

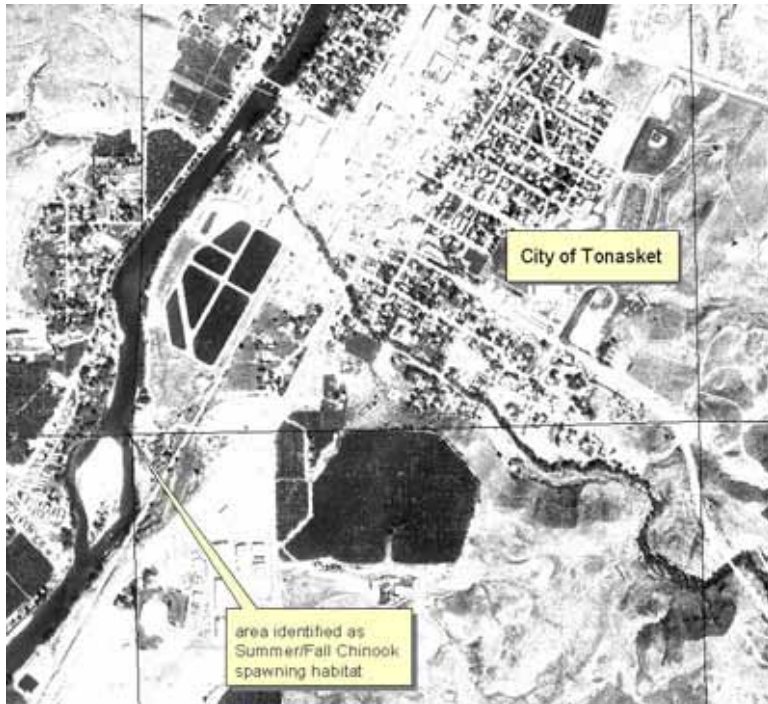
**Figure 5-2. Chinook Salmon Spawning Habitat in Bonaparte Creek.**

Summer/fall chinook salmon are known to use the mainstem Okanogan River as well as the Similkameen River to Enloe Falls (Figure 5-2). . The mainstem Okanogan River is used for migration northward to Canadian waters. Most of the known summer/fall chinook spawning areas are in the Similkameen River. It is unlikely that chinook salmon use Bonaparte Creek, as flows in the fall are less than 5 cubic feet per second (cfs), but spawning has occurred in the mainstem Okanogan River below Bonaparte Creek. **Note about the spawning below the Bonaparte creek portion talk to Linda Hoffman.**

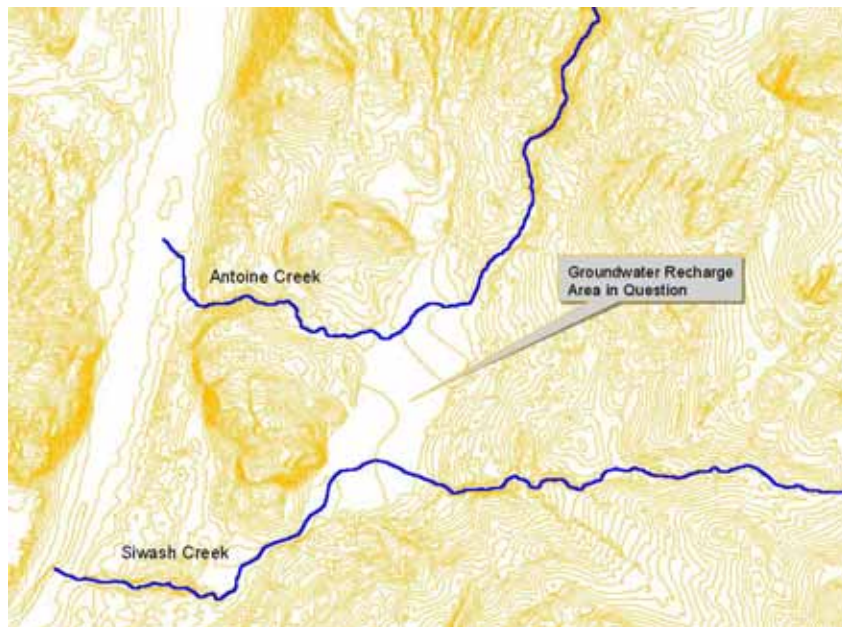
**Figure 5-5. Groundwater recharge questions.**

Irrigation withdrawals peak at this time and may be the reason for such reduced surface flows. Another hypothesis is that Siwash Creek recharges groundwater draining to Antoine Creek, and Siwash Creek will only have surface flows during times when the groundwater “aquifer” is sufficiently recharged to spill water into the Siwash rivulet (**Figure 5-5**). This data gap should be resolved before attempts of summer and fall flow predications in the downstream reach of Siwash Creek are made.

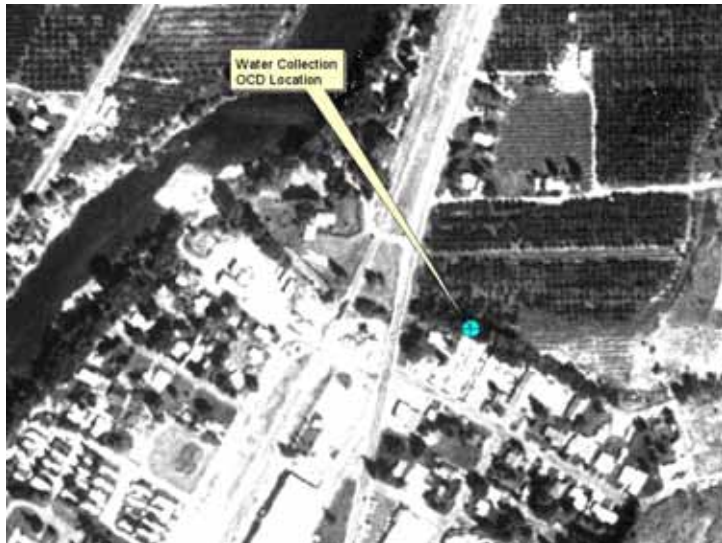
**Figure 5-7.** OCD water quality data collection location in Reach 1.

Data was collected in the same time period for dissolved oxygen, temperature, turbidity, and nutrient information (Figure 5-7).

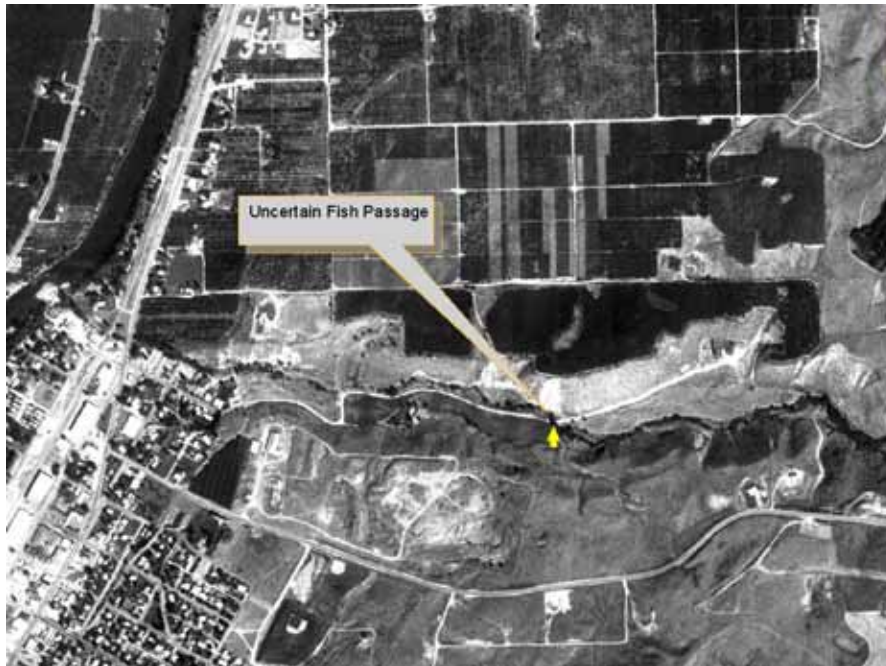
**Figure 5-9.** This area has not been visited, and is a Data Gap.

Fish Passage - Fish passage is assumed good. Siwash Creek has been confined to a channeled trench through the town of Tonasket, but the width of the trench allows for some sinuosity lowering velocities and allowing upstream movement by juvenile fishes. One stream crossing, identified on aerial photo, could pose a passage problem (Figure 5-9).
