Appendix F
Chief Joseph Dam
Hatchery Water Supply Report

Chief Joseph Dam Columbia River, Washington Hatchery Water Supply Study

April 2004

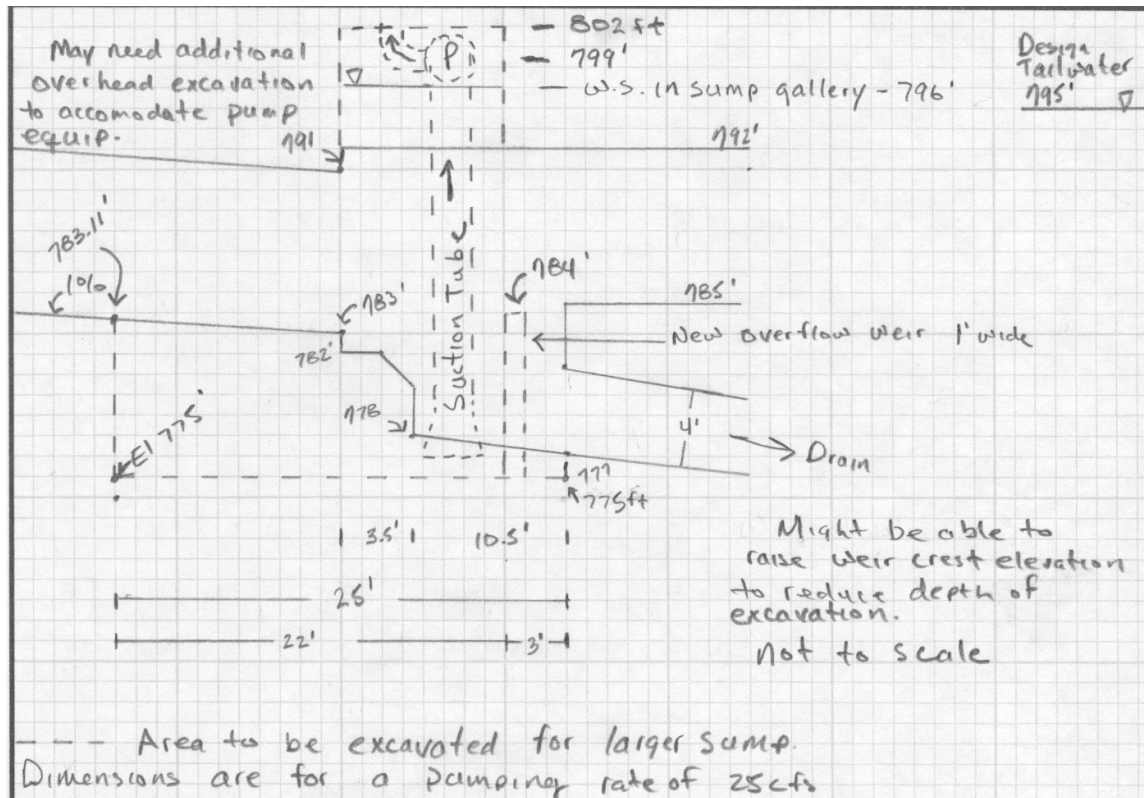
Figure 2. Conceptual Sump Cross Section for Pumping 25 cfs

5.3.1.2. Figure 1 shows a basic schematic of the system and Figure 2 shows a cross-sectional view of the sump and needed modifications to the sump and the chamber ceiling.

5.3.1.3. In addition to the increased sump dimensions, Figure 2 shows other sump chamber modifications that include raising part of the sump chamber ceiling to keep pumping equipment in the dry up to the design tailwater elevation and construction of a weir to always insure the sump is always at a minimum elevation of 784 during low tailwater conditions. Under this configuration, as tailwater elevations exceed 795, the area in the chamber where the pump and motor are located would start to become inundated with water and equipment damage could be expected. When comparing Figures 1 and 2 it might be noticed that the sump water surfaces differ by two feet. This is because the first step was to estimate system head losses and the sump water surface was initially chosen to be at 782. As the sump modifications were developed the elevation was changed to 784. This difference is not a factor at this point in the conceptual designs.

5.3.1.7. The current pump capacity of the sump in its current configuration is about 10 to 14 cfs. Due to the presence of the 4-foot drain at the end of the sump, the installation of a weir structure similar to that in Figure 2 would be needed to insure that the sump is always full of water. This weir would take up space and further cut down pumping capacity. The other issues discussed above, such as the tailwater elevation, still would apply.

cubic feet for the version shown in Figure 2. As pumping rates are reduced so is the required sump size. The diameter of the supply pipeline would also be slightly reduced due to the lower pumping rate. Preliminary calculations indicate that a 20-inch diameter steel pipe would be required as opposed to a 22-inch diameter pipe for a 25 cfs pumping rate.

6.2.3. A new sump room will be required. Currently the sump is about 10.5 feet long, 4.5 feet wide and 4.5 feet deep (See Figure 2). The new sump room needs to be 18 feet long by 6 feet wide by 7 feet deep. In order to build this room approximately 21 feet of existing tunnel and sump floor slab has to be removed and replaced with a new floor approximately 7 feet deep and 6 feet wide. Also approximately 7 feet of one relief tunnel wall has to be removed and replaced by a new wall which will widen the interior of the room to 6 feet. The ceiling of the existing tunnel would remain but an extension of 1 feet of new ceiling would have to be added on to make the room 6 feet wide by 18 feet long. Approximately 11 feet of the ceiling over the existing sump would be removed and a new raised ceiling constructed to accommodate the pump chamber. A new overflow weir will be added in the sump room between the bottom of the pump intake and the entrance to the 4 foot diameter drain outlet. In order to construct the new sump and pump chamber, a large portion of impervious and random fill would have to be removed and replaced or a shaft would have to be excavated through the fill. The shaft could be made a permanent feature for access to the pump.

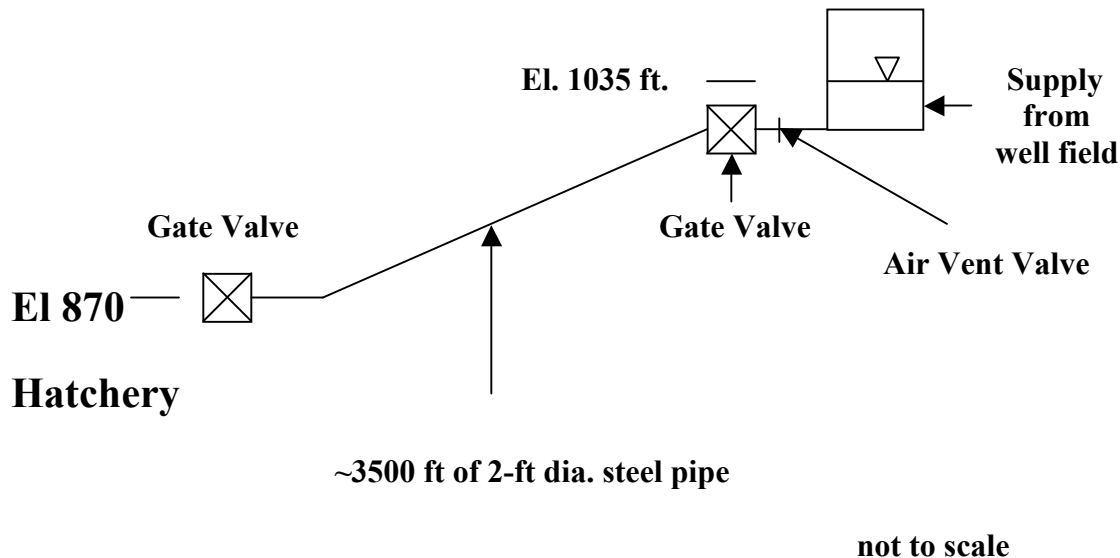
Figure 3. Well Field Supply System Schematic

5.3.2.2. Based on the estimate of well yields (150 gpm), about 100 wells would be needed to supply the total ground water requirement of 35cfs for both summer/fall and spring Chinook. In addition, a storage tank 30-feet in diameter and 20-feet tall would be required. This amount of storage would require the well pumps to be running about 90% of the time. If this value needs to

be lower, the capacity of the tank would need to be larger. Figure 3 shows a schematic of the system.

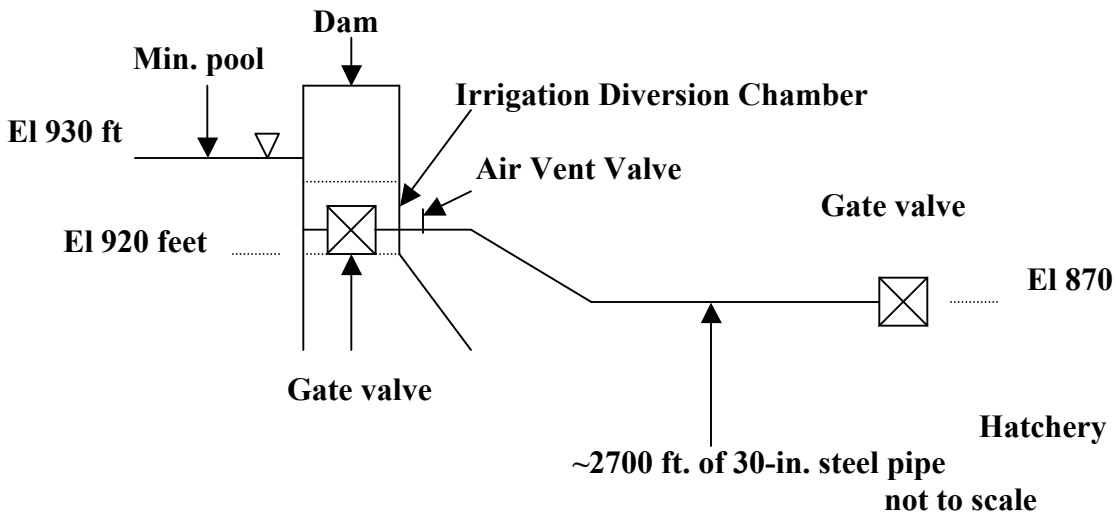
Figure 4. Irrigation Diversion Schematic

5.3.3.2. The hatchery would require a 45 cfs supply of forebay water. Again, assuming a delivery point elevation of 870 feet, and using the Chief Joseph minimum operating pool of 930 feet (60 feet of head), calculations indicate that a 30-inch diameter (assumed steel for

calculations) would supply the required 45 cfs under minimum pool conditions. Using this scheme, one of the inlets and outlets would be opened, and the required pipe placed through the dam and the space between the outside of the pipe and the inlet would be sealed. The pipe system would continue on to the hatchery delivery point and terminate with a gate valve. A trash rack would need to be fabricated as well as a stop log system. For safety purposes a gate valve and an air vent valve (to prevent low pressures that could occur under some conditions) would also be installed near the intake end of the pipe. The system would be operated with the upstream gate valve in the fully opened position with flow to the hatchery controlled by the downstream gate valve. Figure 4 shows a schematic diagram of the system using the irrigation diversion.
